# IMPORTANT PRODUCT INFORMATION

**Product:**      **CIMPLICITY® Control, Version 2.1**

CIMPLICITY Control Version 2.1 is an IEC 1131-3 based programming product for use with GE Fanuc Series 90™-30 (Models 350, 351, 352 and 360) and Series 90™-70 controllers. CIMPLICITY Control runs under Windows® 95 and Windows NT® 4.0. Built on the latest Microsoft technology, CIMPLICITY Control is designed to adhere to industry standards including Microsoft Foundation Classes (MFC) 4.0, ODBC, and OLE 2.0, making CIMPLICITY Control easy to use and integrate with other applications.

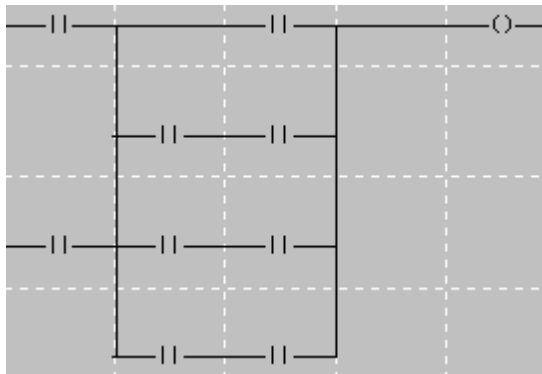
1. **Incorrect Logic Solution:** Version 2.0 Service Pack 3 and Version 2.01 corrects a problem with logic solution in Series 90-30s using CIMPLICITY Control. RLD programs with the following construction will not solve correctly if stored with Version 2.0. Refer to Field Service Bulletin M-04-98-01 “CIMPLICITY Control Release 2.0 Safety Alert “ for more information.

This location, where 3 contacts are ORed together will not solve correctly.

To fix this problem, install Version 2.01 and then do a Rebuild All of each CIMPLICITY Control Series 90-30 folder.

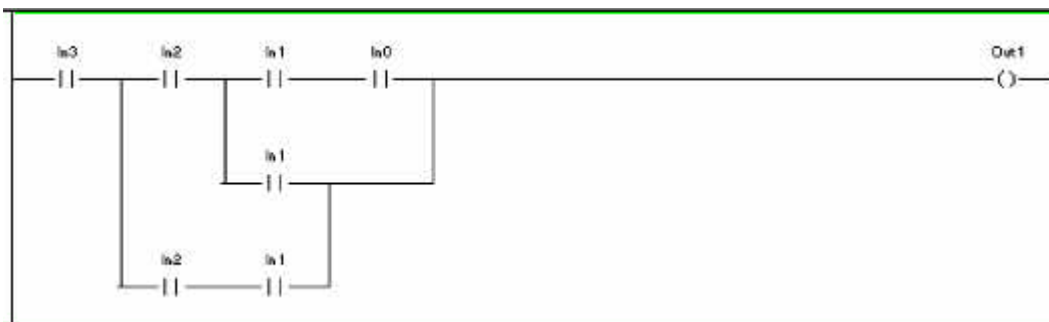
2. **Parameter Edit dialog box.** The Parameter Edit dialog box allows 64 characters for the description field, but will display only 57 characters from the Header dialog box.
3. **Seventy or more transitional contacts in same rung.** If using 70 to 80 transition contacts in the same rung in Accept or Normalize mode, premature termination of CIMPLICITY Control may occur which will cause you to lose changes since your last Save.
4. **Deleting all instructions in a rung does not delete the rung.** To delete a rung, you must select the rung by clicking to the left of the power rail and then delete the rung.
5. **Complex 90-30 Boolean rungs failing on compile.** Some 90-30 complex boolean rungs, such as the one in the following example, fail on compile. The error message “Logic sub-path cannot enter in the middle of another sub-path” is generated.
